VICTIM FATALITY STUDY OF TRAFFIC ACCIDENT AT KM SBY 106+200 (JALAN PANTURA PROBOLINGGO- SITUBONDO) IN EFFORTS TO REDUCE THE TRAFFIC ACCIDENT RISK

Abstract

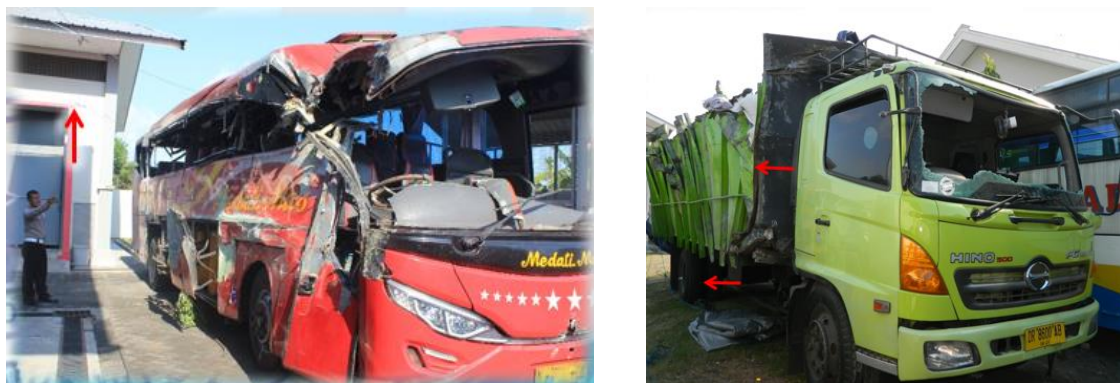
Figure 1. The condition of the buses and trucks involved in the accident

In terms of the bus's condition, the bus body is reconditioned with an iron plate with corrosion. At the time of the incident, the driver's cabin's iron plate was badly damaged when it collided with the truck's body.

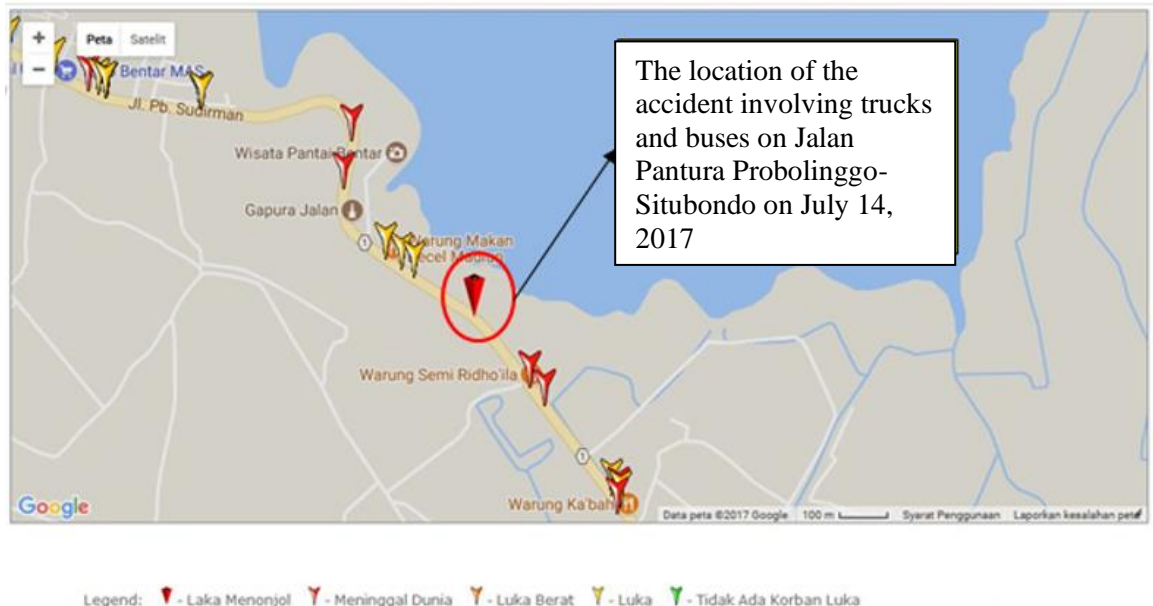
The incident location is also known as a black spot location because several accidents have also occurred around the location. Based on this data, it can be seen that there is:

Front – Front Accident	: 8
Back – Front Accident	: 2
Single Accident	: 1
Accident with Pedestrian Casualties	: 1

Figure 2. Accident data according to IRSMS at the location of the incident

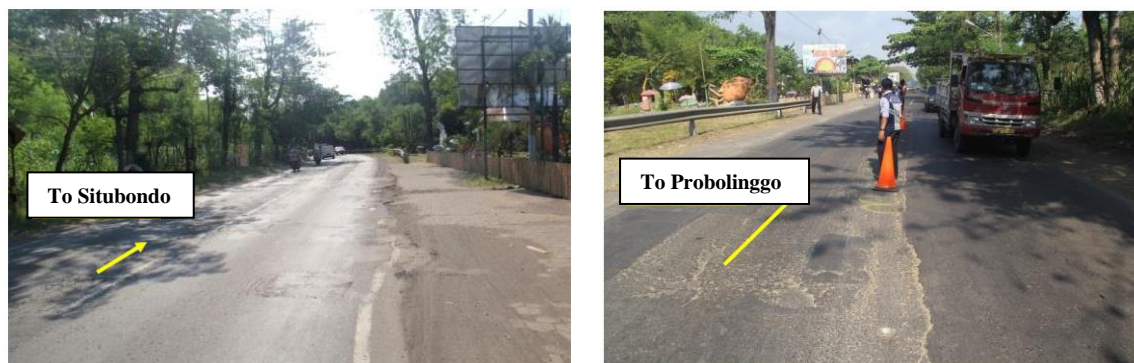
Jalan Pantura Gending Probolinggo-Situbondo is a national road with type 2 / 2UD (two undivided two-way lanes) and a primary arterial road function. The pavement construction is flexible pavement with a width of 7 meters for two directions with a shoulder of 1 meter on both sides not paved. Based on the National Transportation Safety Committee (NTSC) report, the road surface conditions were in poor condition at the accident. The road surface has many holes, uneven, and patches.

Figure 3. The condition of the pavement at the location of the incident

Superelevation improvements need to be done, from the initial 3% to 5%, according to a bend radius of 383 meters. In addition, it is necessary to level the road surface and give the markings firmness. Several recommendations regarding road equipment include:

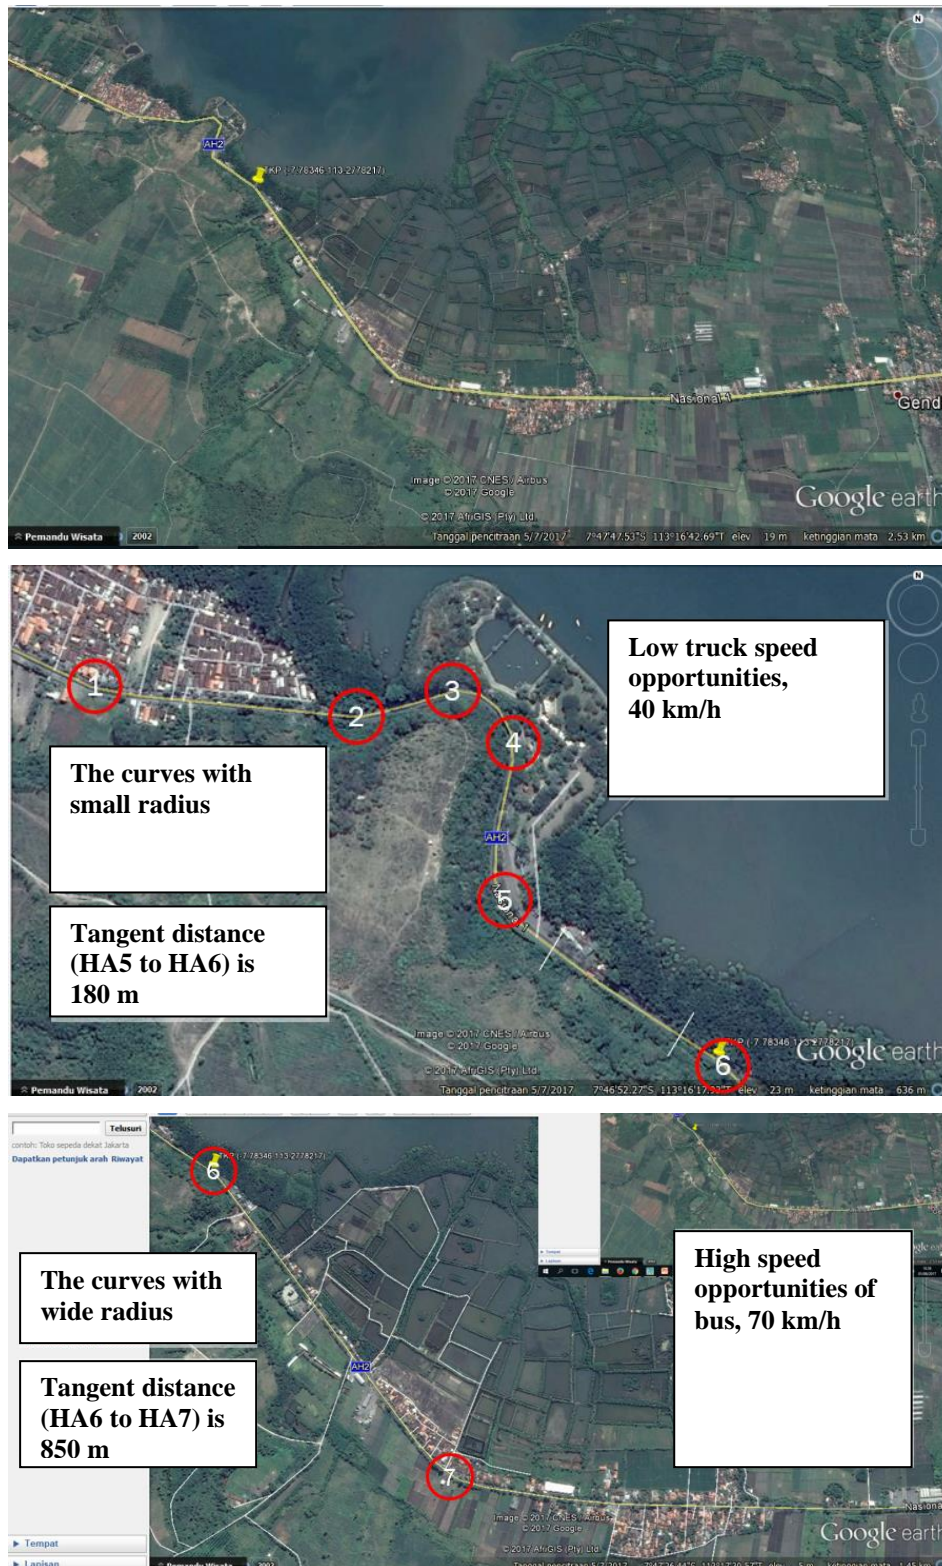
Figure 4. Orientation of the horizontal alignment at the scene

The horizontal alignment orientation shows that from the direction of Probolinggo, the truck is passing several turns with a small radius (R), so it is likely that the truck will speed slowly. However, from the direction of Situbondo, the road conditions are straight, and there is only one bend with a large R which causes the possibility of the bus driving at high speed at the scene of the incident.

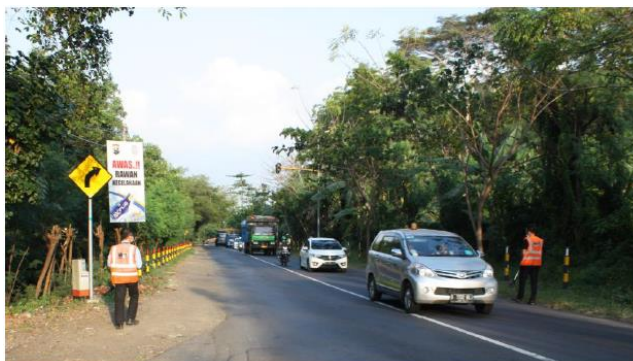
Meanwhile, in terms of signage, there is a warning sign for a bend to the right ± 137 meters before the accident site from Situbondo to Probolinggo (Figure 3). The warning signs are visible. There is a warning sign for a bend to the left ± 109 meters before the accident location from Probolinggo to Situbondo (Figure 3). The warning signs are visible. There is a warning sign for a bend to the left ± 50 meters before the accident location from Probolinggo to Situbondo (Figure 3). A thick tree covered the warning sign. There is a middle mark, and the side of the road is white. However, some of the conditions are already blurry. At the location of the accident, the markers were lost due to the overlay process. There are also side markers missing. There is also a warning light about 112 meters before the accident scene from Situbondo to Probolinggo. However, the warning light did not work. This warning light provides a warning in both directions, both vehicles heading to Probolinggo and vehicles heading to Situbondo.

(a) Sign for a right bend from the direction of Probolinggo

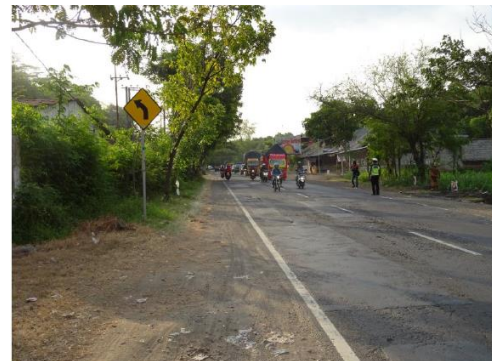
(b) Sign for a left bend from the direction of Situbondo

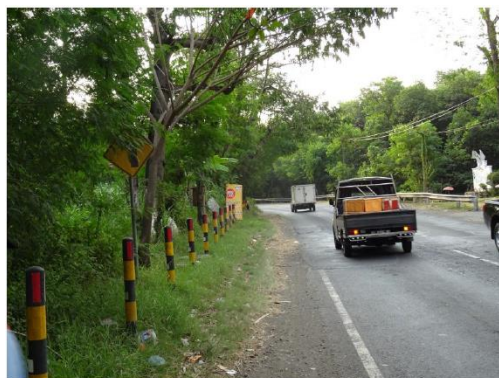
(c) Warning signs before location

There are no accident-prone warning signs in terms of road equipment, 500 meters before the location of the incident. This absence can create hazards due to the driver's lack of attention if they enter an accident-prone location. Besides, many PJUs around the location is also covered with trees. The warning light at the scene also does not work.

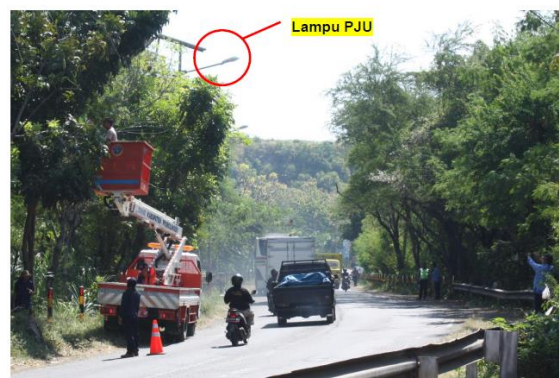
(d) Public Street Lighting at the location

1. Repair of the guard rail on the left side of the road from west to east, because the condition is not good;
2. Cutting branches and branches of trees that obstruct visibility and traffic signs;
3. Removal of boulders by the side of the road and other material that is a potential hazard;
4. Installation of accident-prone warning signs;
5. Installation of signs prohibiting overtaking of other vehicles;
6. Painting the road markings and adding two solid line double markings to the curves;
7. Installation of a delineator (Chevron) at the corner;
8. Installation of road studs with a metal deflector;

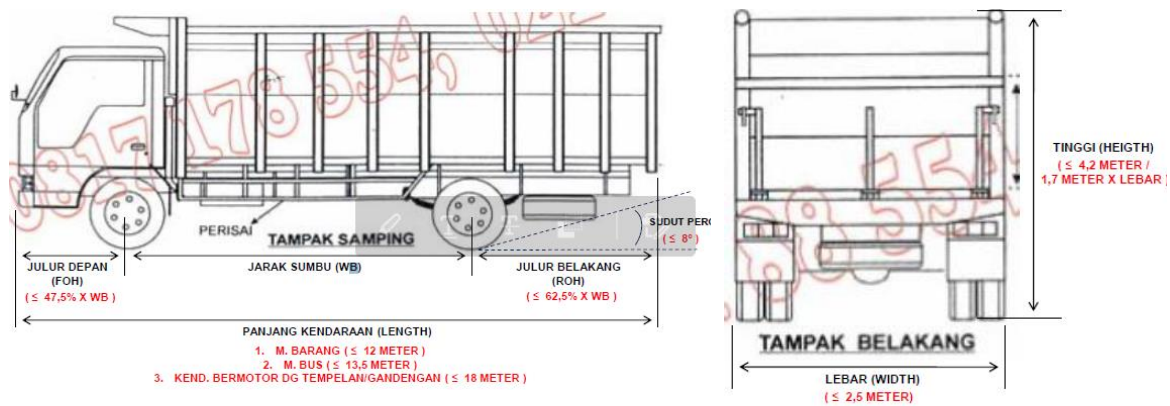
Meanwhile, the measurement results for the axle distance of the truck are 5,530 mm. Thus, it was found that there was a shift in the rear axis position by 930 mm. This is incompatible with PP No. 55 year 2012 about “Kendaraan” Article 54. Rear Over Hang (ROH) measurement shows that the truck has an ROH of 3,600 mm. Thus, the truck’s ROH has exceeded 62.5% of the distance between the axles (maximum 2,875 mm). This is incompatible with PP No. 55 year 2012 about “Kendaraan” Article 54. In the truck tub measurement, it was found that the width dimensions of the tub exceeded the provisions, namely 2,870 mm. Meanwhile, the rules of PP No. 55 year 2012 about “Kendaraan” article 54, the maximum width of the vehicle is only allowed to be 2,500 mm. This is exacerbated by the fact that the truck’s payload is 25 tonnes (over the load limit of 18 tonnes).

Changes in vehicle dimensions will certainly be a hazard. When the vehicle crosses the corner, the width of the vehicle will increase. Vehicles that are over-dimensioned will endanger other vehicles. The distance between the axles that are not being extended according to the rules will also increase the vehicle’s turning radius so that the required vehicle prow will also be even greater. In terms of vehicle stability, changes in dimensions will also affect the vehicle’s centre of gravity. The body of the vehicle that is extended can certainly be dangerous if the vehicle crosses a corner.

Figure 6. Vehicle Dimension Based on PP No. 55 year 2012 about “Kendaraan”

In terms of the truck's dimensions, if there is a plan from the vehicle owner that will change/modify the cargo body, the planning of the change must not violate Article 54 and 55 PP 55 the year 2012. In addition, changes in design that are made must also meet the vehicle's technical and roadworthiness requirements. Thus, changes in load through width, material, and reinforcing structure carried out by the car body must comply with the conditions stated in Article 54 and 55. There is a need for strict enforcement against welding workshops that do not have a business license so that the welding workshop makes or modifies cargo tanks haphazardly.

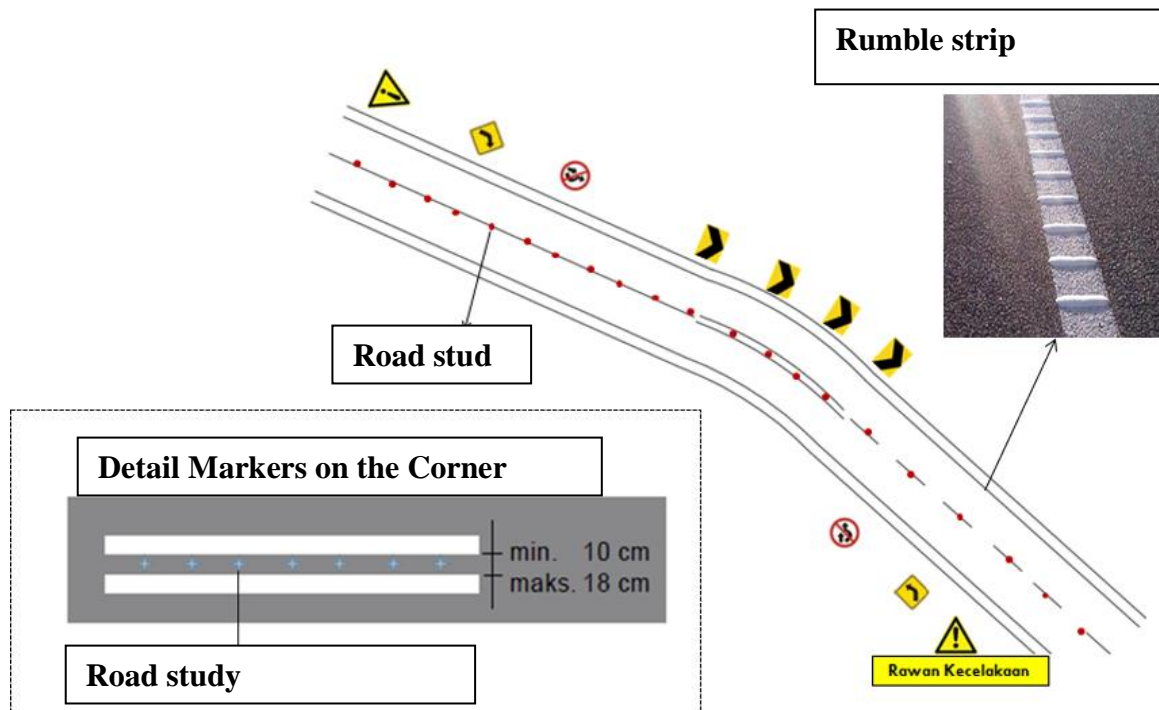
Figure 7. Recommended signs and markers at the scene of the incident

9. Use of tactile tape on the outer side markings of the road body;
10. Use of materials that are easily crushed if hit, compared to rigid materials such as concrete and steel for guideposts; for example, by using PVC pipe or can use hard rubber;
11. Installation of the road dividing stakes, paying attention to the concrete below ground level, not above ground level.
