# Victim Fatality Study of Traffic Accident at KM SBY 106+200 (Jalan Pantura Probolinggo-Situbondo) in Efforts to Reduce the Traffic Accident Risk

## **VICTIM FATALITY STUDY OF TRAFFIC ACCIDENT AT KM SBY 106+200 (JALAN PANTURA PROBOLINGGO- SITUBONDO) IN EFFORTS TO REDUCE THE TRAFFIC ACCIDENT RISK**

### **Abstract**

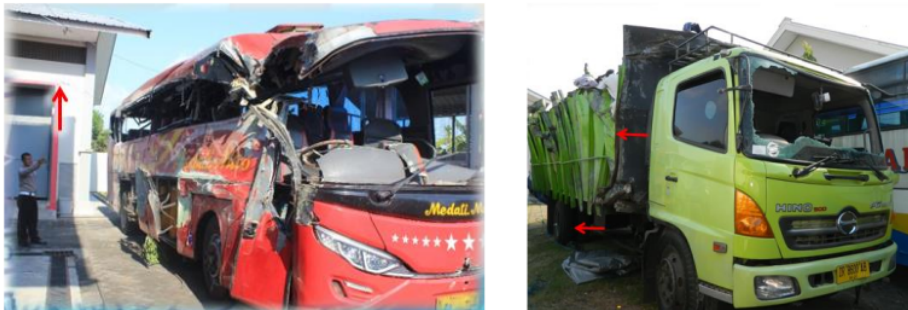
Figure 1. The condition of the buses and trucks involved in the accident

In terms of the bus's condition, the bus body is reconditioned with an iron plate with corrosion. At the time of the incident, the driver's cabin's iron plate was badly damaged when it collided with the truck's body.

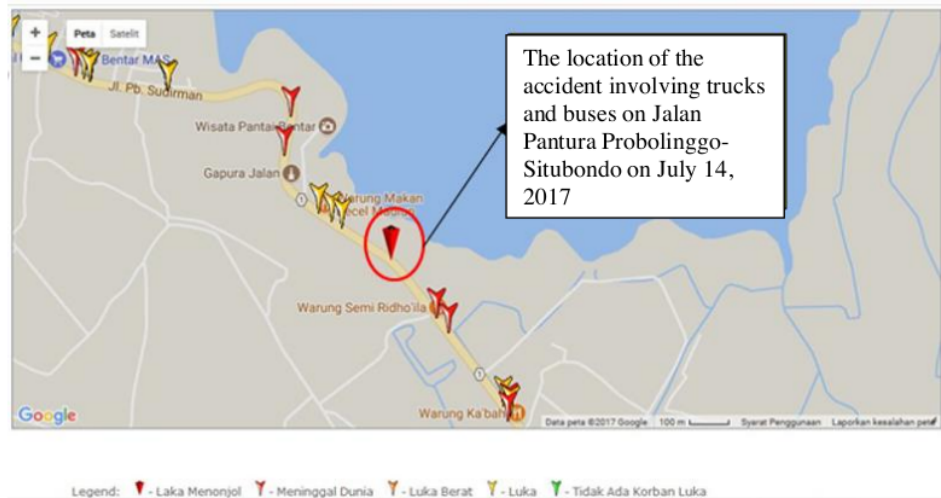
The incident location is also known as a black spot location because several accidents have also occurred around the location. Based on this data, it can be seen that there is:

Front – Front Accident	: 8
Back – Front Accident	: 2
Single Accident	: 1
Accident with Pedestrian Casualties	: 1

Figure 2. Accident data according to IRSMS at the location of the incident

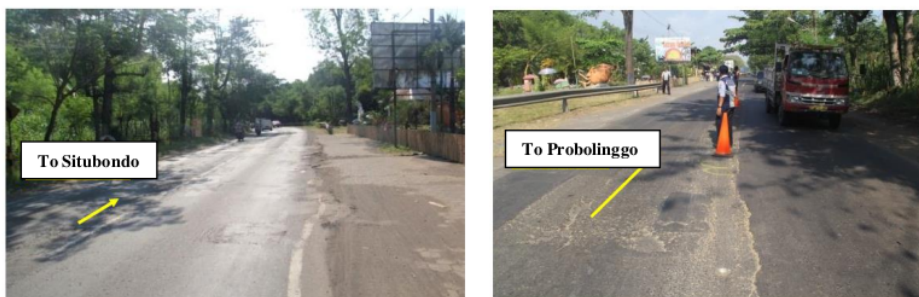
Jalan Pantura Gending Probolinggo-Situbondo is a national road with type 2 / 2UD (two undivided two-way lanes) and a primary arterial road function. The pavement construction is flexible pavement with a width of 7 meters for two directions with a shoulder of 1 meter on both sides not paved. Based on the National Transportation Safety Committee (NTSC) report, the road surface conditions were in poor condition at the accident. The road surface has many holes, uneven, and patches.

Figure 3. The condition of the pavement at the location of the incident

The condition of the road's cross-section (superelevation), which is only 3%, is one of the hazards. This is because superelevation is useful for reducing the amount of centrifugal force that occurs in the corner. If the superelevation is not up to standard, the vehicle will be thrown out of the track. Potential hazards also come from road pavement conditions. The pavement at the location of the incident is uneven, bumpy, and has many patches. The uneven and bumpy road conditions on the side of the road also cause the potential for vehicles to drive more in the middle. The road markings that are blurry and some have been lost also cause hazards because there is no clear curb.

Superelevation improvements need to be done, from the initial 3% to 5%, according to a bend radius of 383 meters. In addition, it is necessary to level the road surface and give the markings firmness. Several recommendations regarding road equipment include:

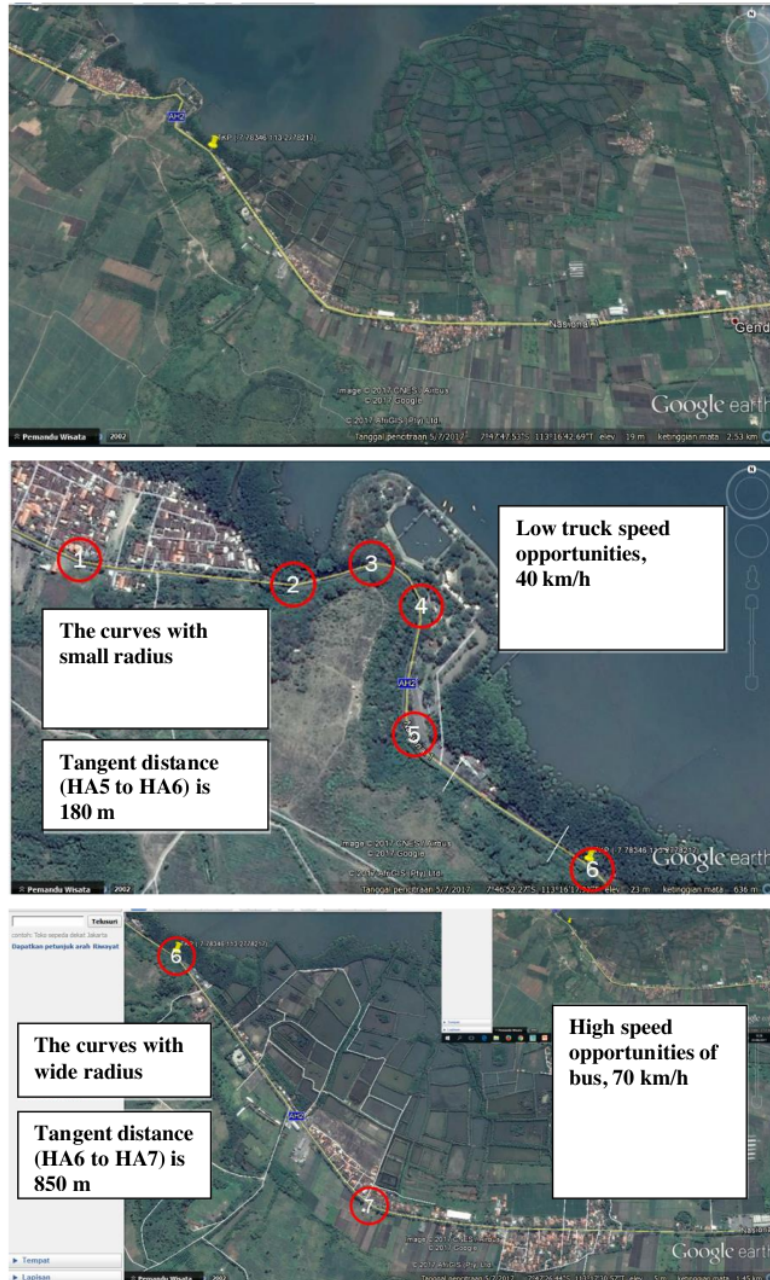
Figure 4. Orientation of the horizontal alignment at the scene

The horizontal alignment orientation shows that from the direction of Probolinggo, the truck is passing several turns with a small radius (R), so it is likely that the truck will speed slowly. However, from the direction of Situbondo, the road conditions are straight, and there is only one bend with a large R which causes the possibility of the bus driving at high speed at the scene of the incident.

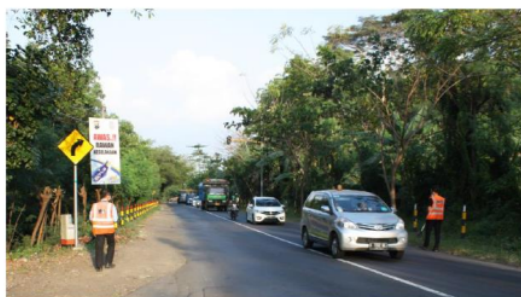
Meanwhile, in terms of signage, there is a warning sign for a bend to the right  $\pm$  137 meters before the accident site from Situbondo to Probolinggo (Figure 3). The warning signs are visible. There is a warning sign for a bend to the left  $\pm$  109 meters before the accident location from Probolinggo to Situbondo (Figure 3). The warning signs are visible. There is a warning sign for a bend to the left  $\pm$  50 meters before the accident location from Probolinggo to Situbondo (Figure 3). A thick tree covered the warning sign. There is a middle mark, and the side of the road is white. However, some of the conditions are already blurry. At the location of the accident, the markers were lost due to the overlay process. There are also side markers missing. There is also a warning light about 112 meters before the accident scene from Situbondo to Probolinggo. However, the warning light did not work. This warning light provides a warning in both directions, both vehicles heading to Probolinggo and vehicles heading to Situbondo.

(a) Sign for a right bend from the direction of Probolinggo

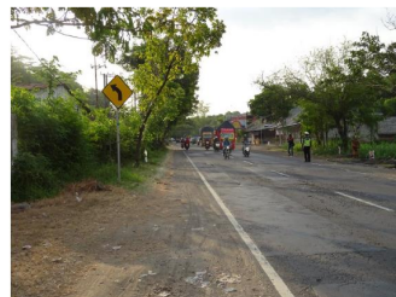
(b) Sign for a left bend from the direction of Situbondo

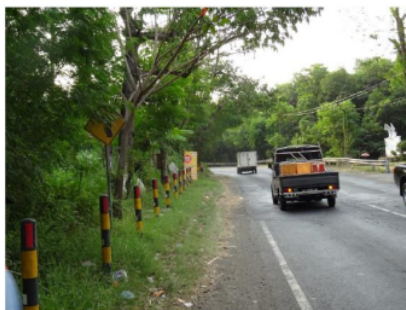
(c) Warning signs before location

There are no accident-prone warning signs in terms of road equipment, 500 meters before the location of the incident. This absence can create hazards due to the driver's lack of attention if they enter an accident-prone location. Besides, many PJUs around the location is also covered with trees. The warning light at the scene also does not work.

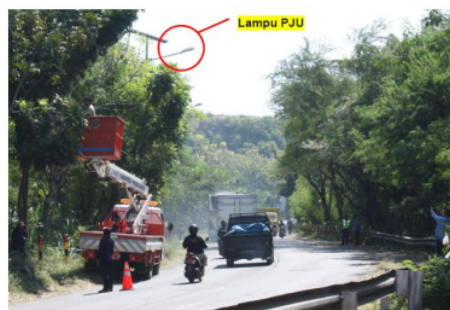
(d) Public Street Lighting at the location

1. Repair of the guard rail on the left side of the road from west to east, because the condition is not good;
2. Cutting branches and branches of trees that obstruct visibility and traffic signs;
3. Removal of boulders by the side of the road and other material that is a potential hazard;
4. Installation of accident-prone warning signs;
5. Installation of signs prohibiting overtaking of other vehicles;
6. Painting the road markings and adding two solid line double markings to the curves;
7. Installation of a delineator (Chevron) at the corner;
8. Installation of road studs with a metal deflector;

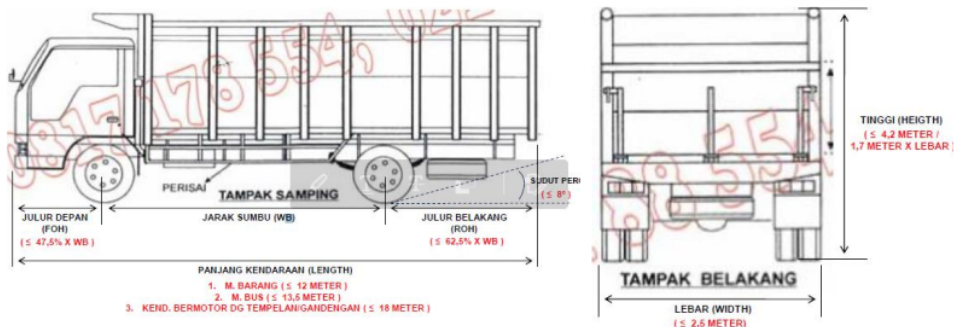
Meanwhile, the measurement results for the axle distance of the truck are 5,530 mm. Thus, it was found that there was a shift in the rear axis position by 930 mm. This is incompatible with PP No. 55 year 2012 about "Kendaraan" Article 54. Rear Over Hang (ROH) measurement shows that the truck has an ROH of 3,600 mm. Thus, the truck's ROH has exceeded 62.5% of the distance between the axles (maximum 2,875 mm). This is incompatible with PP No. 55 year 2012 about "Kendaraan" Article 54. In the truck tub measurement, it was found that the width dimensions of the tub exceeded the provisions, namely 2,870 mm. Meanwhile, the rules of PP No. 55 year 2012 about "Kendaraan" article 54, the maximum width of the vehicle is only allowed to be 2,500 mm. This is exacerbated by the fact that the truck's payload is 25 tonnes (over the load limit of 18 tonnes).

Changes in vehicle dimensions will certainly be a hazard. When the vehicle crosses the corner, the width of the vehicle will increase. Vehicles that are over-dimensioned will endanger other vehicles. The distance between the axles that are not being extended according to the rules will also increase the vehicle's turning radius so that the required vehicle prow will also be even greater. In terms of vehicle stability, changes in dimensions will also affect the vehicle's centre of gravity. The body of the vehicle that is extended can certainly be dangerous if the vehicle crosses a corner.

Figure 6. Vehicle Dimension Based on PP No. 55 year 2012 about "Kendaraan"

In terms of the truck's dimensions, if there is a plan from the vehicle owner that will change/modify the cargo body, the planning of the change must not violate Article 54 and 55 PP 55 the year 2012. In addition, changes in design that are made must also meet the vehicle's technical and roadworthiness requirements. Thus, changes in load through width, material, and reinforcing structure carried out by the car body must comply with the conditions stated in Article 54 and 55. There is a need for strict enforcement against welding workshops that do not have a business license so that the welding workshop makes or modifies cargo tanks haphazardly.

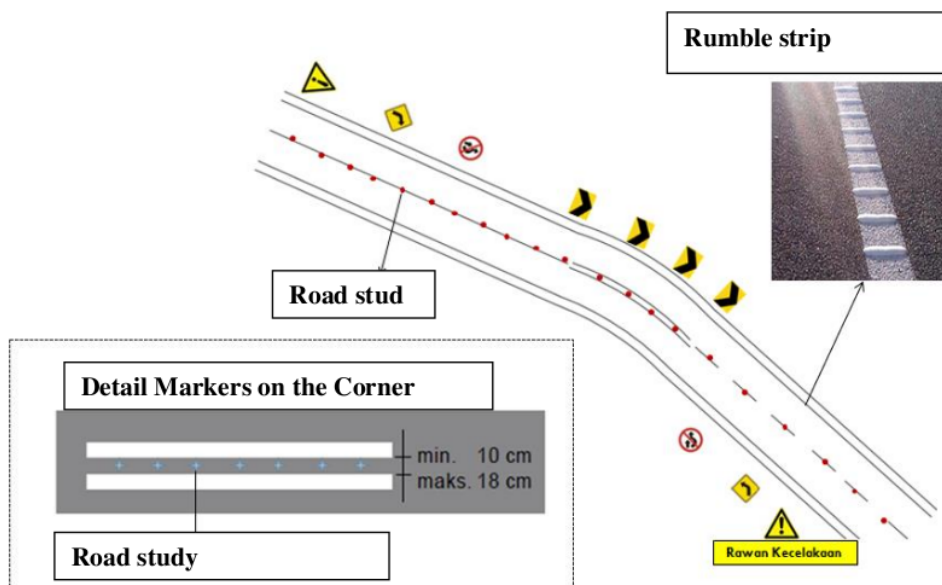
Figure 7. Recommended signs and markers at the scene of the incident

9. Use of tactile tape on the outer side markings of the road body;
10. Use of materials that are easily crushed if hit, compared to rigid materials such as concrete and steel for guideposts; for example, by using PVC pipe or can use hard rubber;
11. Installation of the road dividing stakes, paying attention to the concrete below ground level.
