ANALYSIS OF HIGH-FATALITY ACCIDENT ON TOLL ROAD AND ITS COUNTERMEASURES (CASE STUDY: TOL CIPULARANG KM 91)

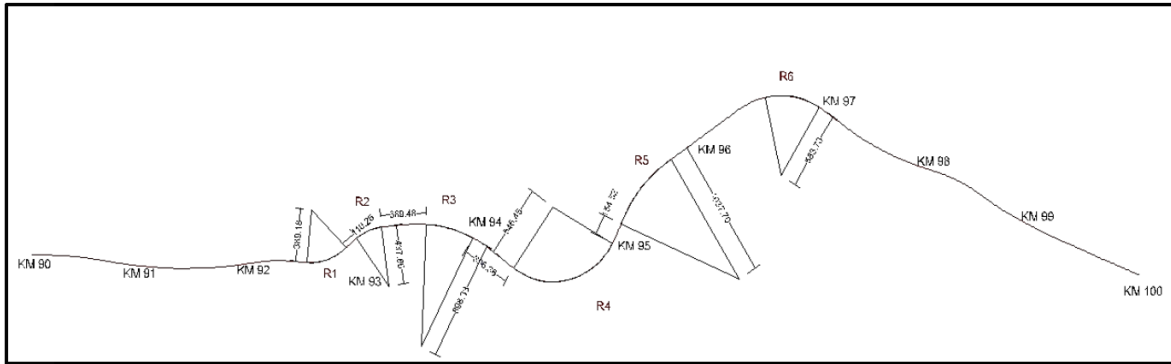
Figure 6. Horizontal Alignment of Cipularang Toll road Segment KM 90 - 100 (Pratama, Siregar, & Marino, 2017)

The KM 90 - 100 segment of the Cipularang Toll Road has more than 7% slope, which exceeds the maximum allowable slope limit of DGH standards (6%) for roads with a design speed of 80 km / h and a critical ramp of 500 meters. In terms of horizontal alignment, the Cipularang toll road segment has met Bina Marga standards. However, the coordination between vertical and horizontal alignment is not well-design, there are turn section with a large slope. which able to trigger a traffic accident (Pratama, Siregar, & Marino, 2017).
